PROJECT CASE STUDY

The Restoration of Rugby
Radio Station

RESTORATION OF RUGBY RADIO STATION

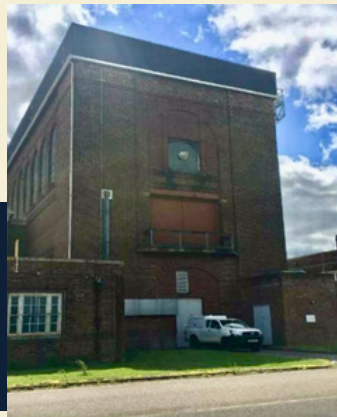
Before restoration, the image above showed Rugby Radio Station in a state of disrepair: dilapidated buildings, overgrown foliage, rusted infrastructure, and neglect had taken a toll on the once-iconic communication hub, portraying a stark contrast to its vibrant past.

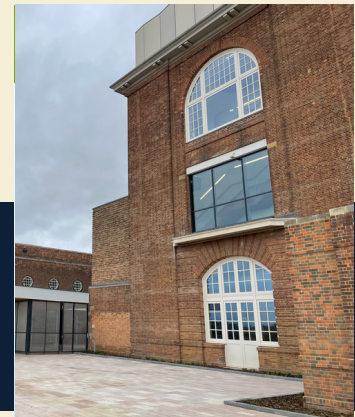
After restoration, Rugby Radio Station appeared revitalized and pristine, thanks to concrete renovations. The buildings showcased a renewed grandeur, with refurbished exteriors, preserved historical elements, and a fresh, well-maintained appearance that breathed new life into the iconic site, honoring its heritage.

Internally, the project involved structural modifications such as creating new brickwork openings up to 900mm, installing concrete and stainless steel lintels above them, and adding over 50 padstones for steel frame support. It also included crack stitching, repointing, closing existing openings, infilling with salvaged glazed bricks, concrete repairs, and M&E chases, all completed by Concrete Renovation Ltd.

Externally, the project included re-pointing with 3.5 NHL, installing external padstones for steel support, closing old openings, and repairing brickwork. It also involved replacing damaged bricks, adding new brick fillets, infill panels at Power Hall and Transmission Hall ends, salvaging and re-bedding coping stones, constructing stair tower extensions, and a reception extension with a wheelchair access window. There was work on lintels, rainwater openings, dismantling old parapets, rendering repairs, leadwork on balconies, stainless steel lintels installation, and brickwork. DOFF cleaning was performed on brickwork and stonework, and bespoke coping was created at high levels.

Concrete Renovations Ltd subcontracted the **GRC** design while installing each GRC unit themselves. Each unit was 600kg, 1m deep, 3.5m long on the Transmission Hall. Concrete Renovations installed a secondary bracket system for installation, prioritizing safety. Following this, they added timber, marine ply, lead, and mastic joints to ensure waterproofing.
